AFRL-RX-WP-TR-2010-4200

**NONDESTRUCTIVE EVALUATION (NDE)
EXPLORATORY DEVELOPMENT FOR AIR FORCE
SYSTEMS**

**Delivery Order 0006: Paint Stripping Effects on Fluorescent Penetrant
Inspection**

Final Report

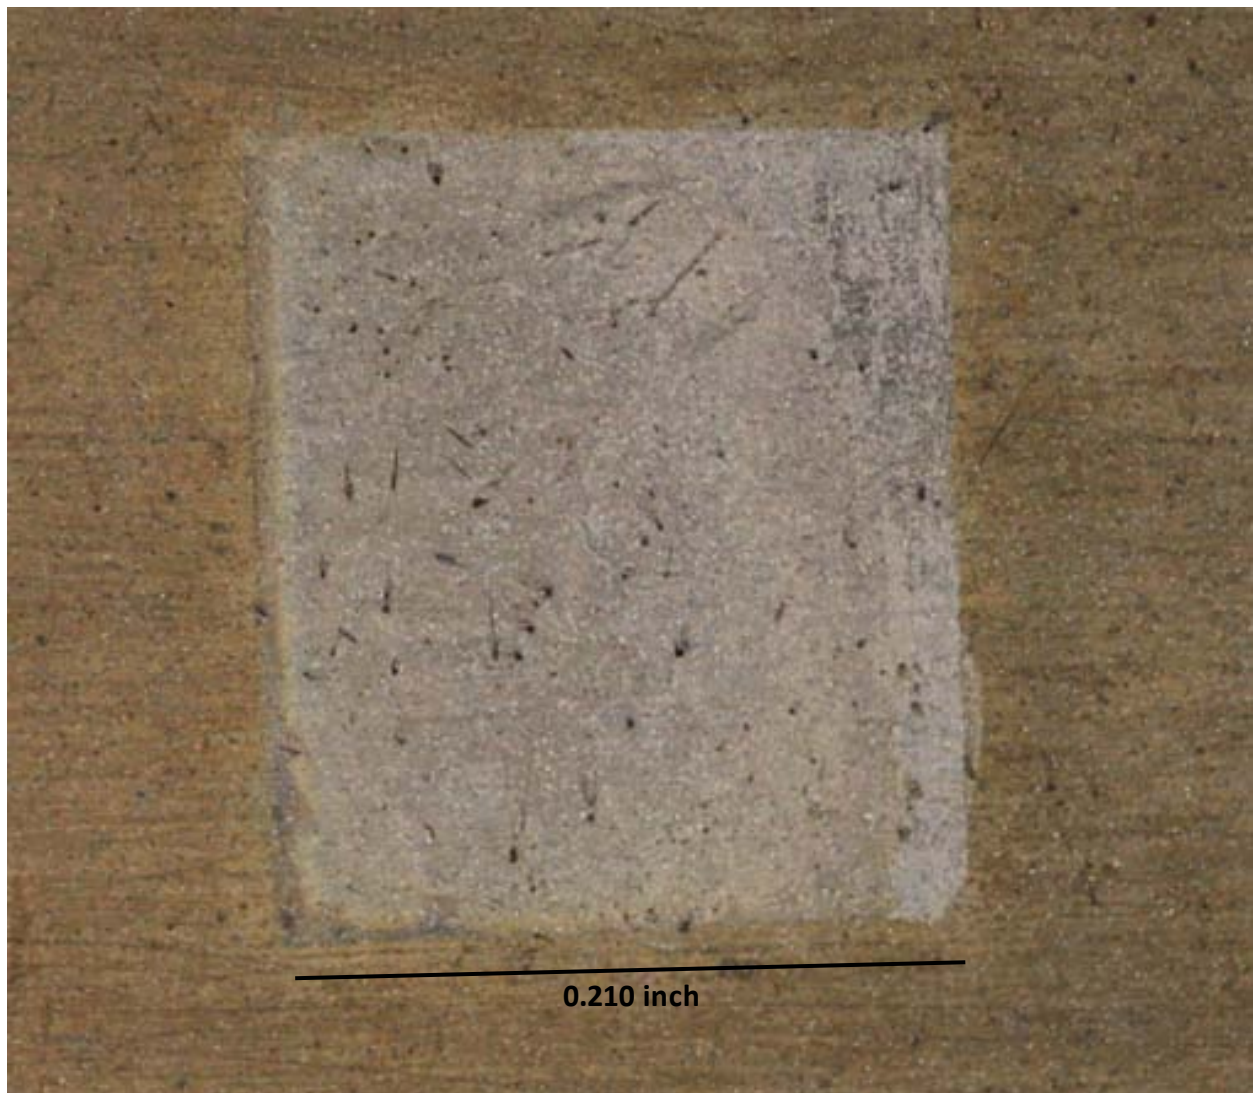
Figure 16. Close-up Picture of the Center of 2024-T3 Specimen 601-14

To the unaided eye nothing unusual was noted on the specimens stripped with plasma (Figure 14 and Figure 15) except for some transverse bands toward each end of 2024-T3 specimen 601-14, pictured at the top of Figure 15. The company (AP Solutions) that had removed paint with atmospheric plasma had used these areas (away from the center cracked area) to empirically develop the stripping parameters for these specimens. Consequentially, over-aggressive paint removal occurred in these areas before the parameters were optimized. When a hand-held 10X magnifier was used to examine these bands more closely, numerous tiny dark and bright spots were observed over the entire stripped surface. Similar features were also observed on the surfaces of the other six specimens. A close-up photograph of the center of specimen 601-14 (Figure 16) shows these features, which became the targets of subsequent microscopic examination as discussed Section 10.6.4.

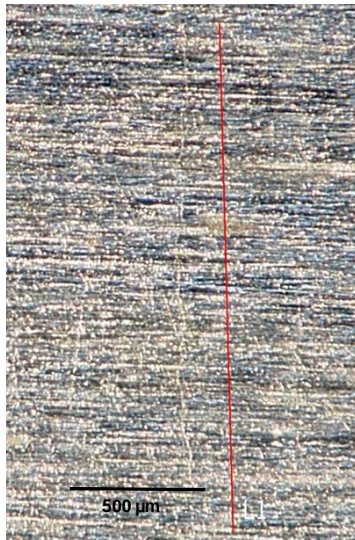
(a) Pre-Paint Optical Image

(b) Post-Strip SEM Image

(c) High Magnification Image

Figure 18. Post-Strip Image of Crack in 7075-T6 Specimen 609-05

Microscopic examination of 7075-T6 specimen 609-05 revealed a long (0.074 inch) and tight crack (Figure 18a), but one that produced a good pre-paint FPI indication (Figure A-2b). The post-strip image in Figure 18b provides a good view of different surface features: 1) media impingement on the specimen surface with little metal upset (small dark spots), 2) metal upset (brighter irregular marks) occasionally bridging the crack and 3) embedded media (large sharp-cornered irregular dark areas). The more highly magnified post-strip image in Figure 18c shows small amounts of media embedded in the crack and metal smear closing part of the crack opening. The post-strip FPI indication (Figure A-2b) was barely visible.
